**THE JONES LIBRARY**  
**AMHERST, MASSACHUSETTS**  
**HISTORIC STRUCTURE REPORT**

**DRAFT 12-22-21**

Prepared for:  
The Town of Amherst  
Amherst, MA

DECEMBER 22, 2021

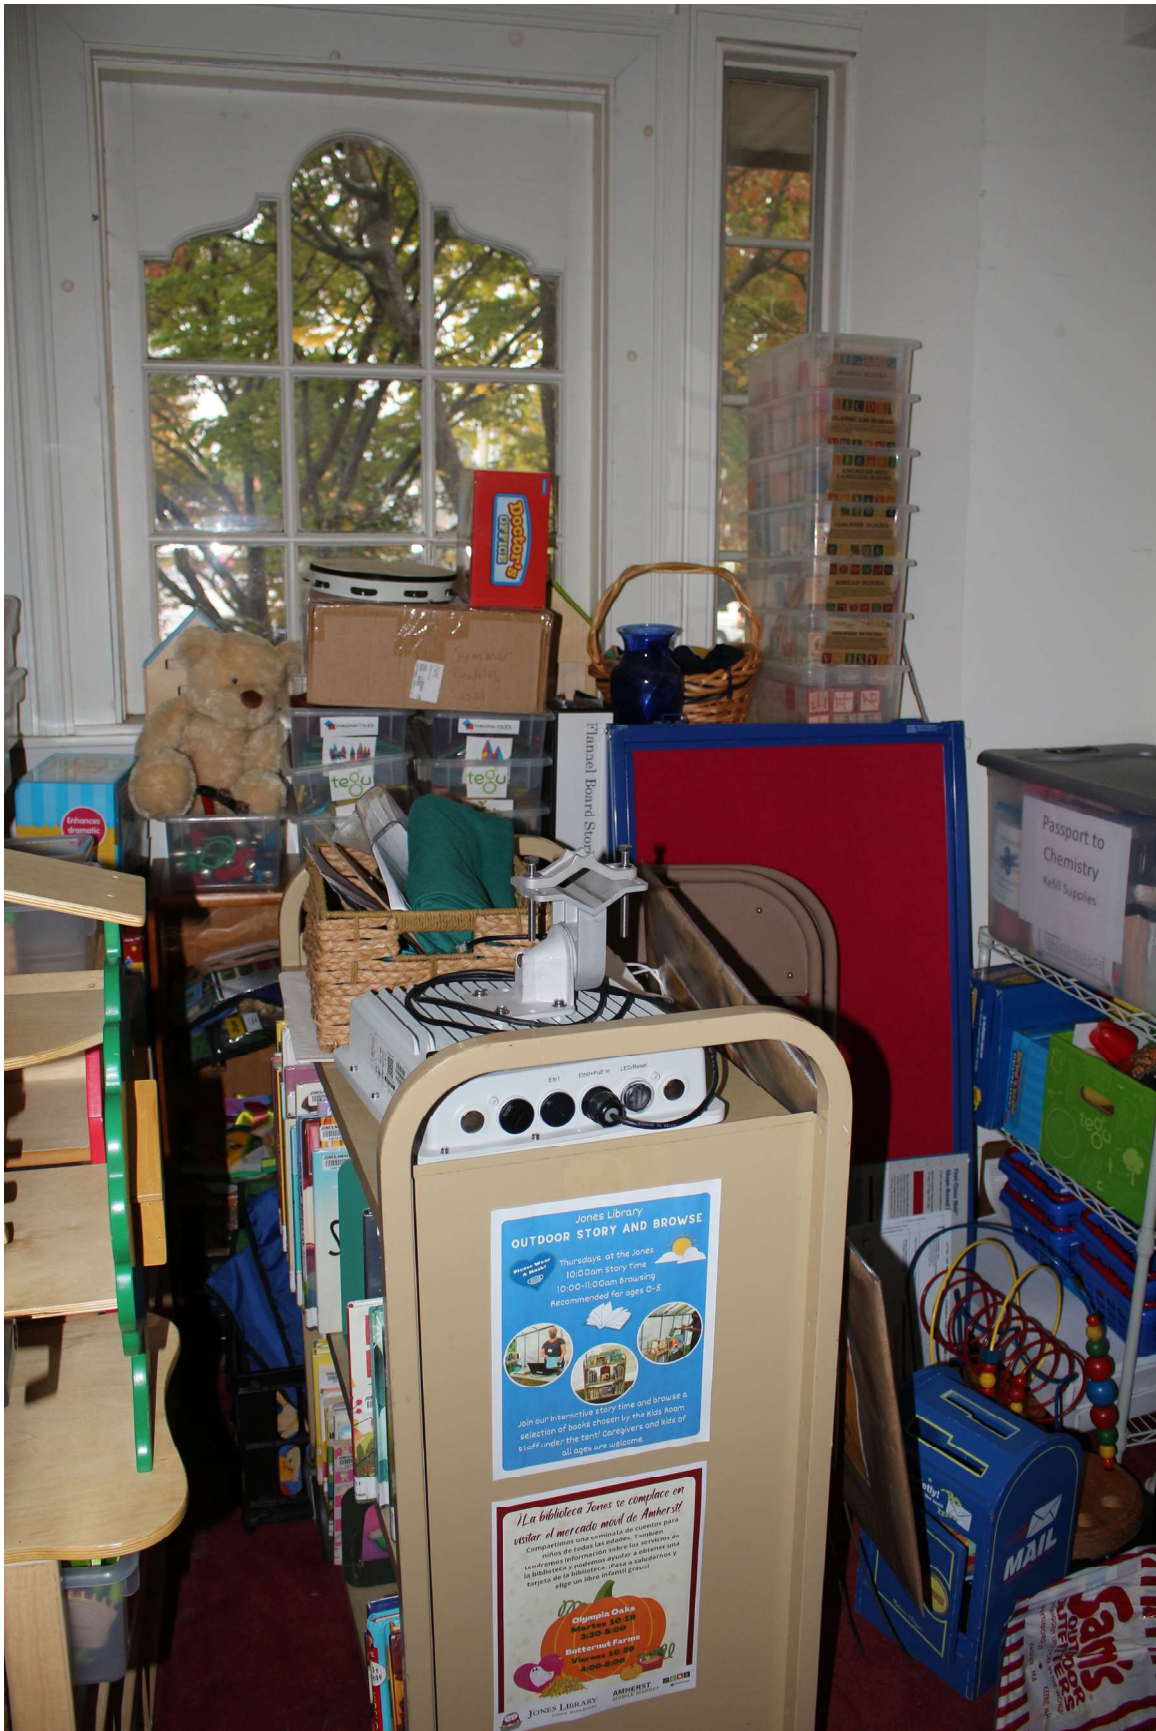
Fig. 8783. West entry vestibule. Lack of space has forced secondary spaces like this entry to be pressed into service as storage space.
